**Fish and Fish Habitat Existing  
Conditions and Preliminary  
Impact Assessment Report**

Highway 401 East of Brockville,  
Planning, Preliminary Design and  
Class Environmental Assessment  
Study, GWP 4111-22-00

August 2025

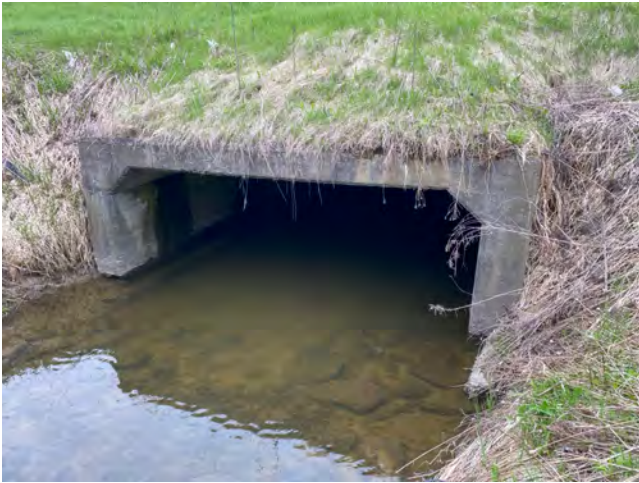
Photo 1: Site WC36; Station ET\_24+364 (Elizabethtown) - Butler's Creek; Highway 401 Eastbound, culvert outlet facing north

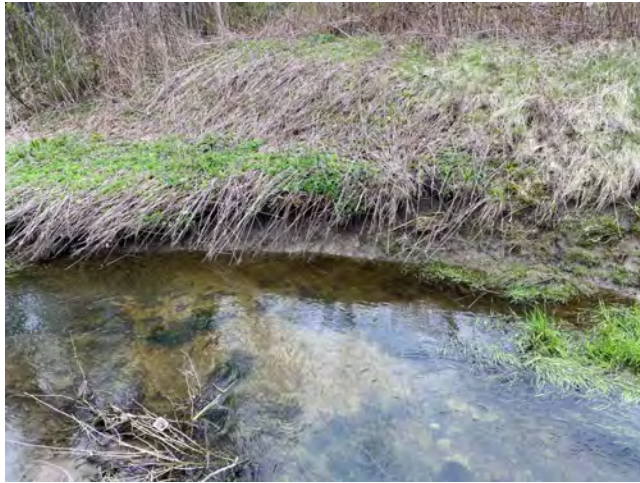
Photo 2: Site WC36; Station ET\_24+364 (Elizabethtown) - Butler's Creek; Highway 401 Eastbound, erosion on west bank facing west

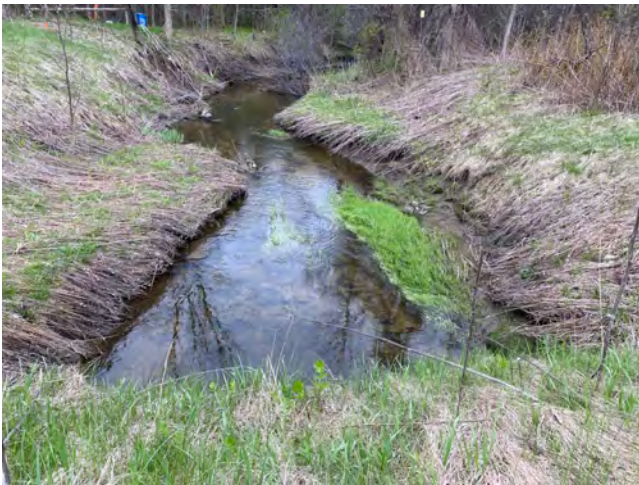
Photo 3: Site WC36; Station ET\_24+364 (Elizabethtown) - Butler's Creek; Highway 401 Eastbound, facing south (downstream)

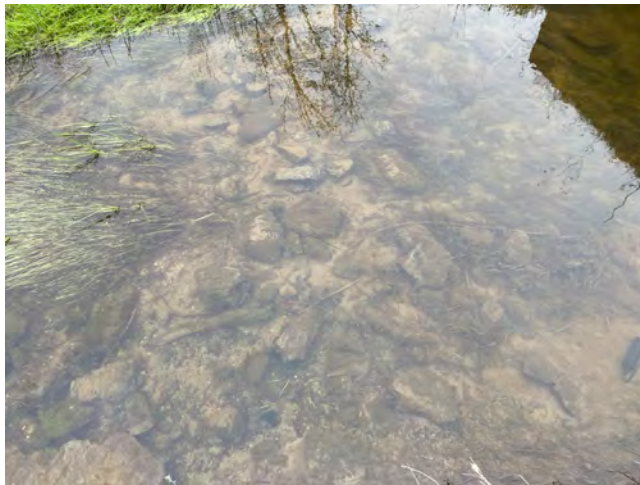
Photo 4: Site WC36; Station ET\_24+364 (Elizabethtown) - Butler's Creek; Highway 401 Eastbound, substrate

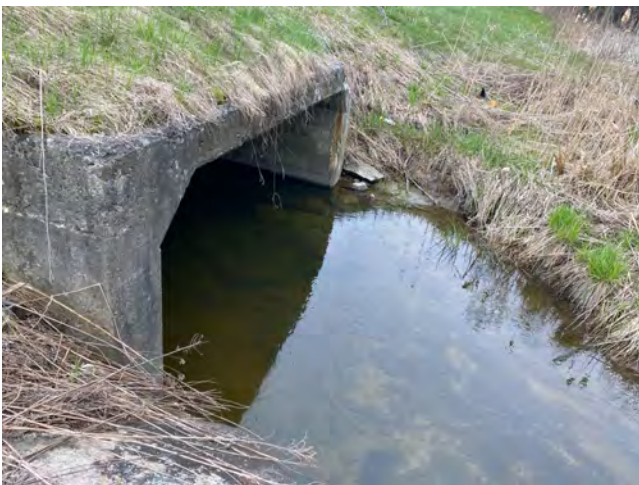
Photo 5: Site WC36; Station ET\_24+364 (Elizabethtown) - Butler's Creek; Highway 401 Westbound, culvert inlet facing southwest

- Removal and replacement of existing 3.6 m span X 1.5 m rise X 50 m length NRFB
- Replacement culvert to be a 4.2 m span by 4.2 m rise. Type of culvert and length to be determined through Detail Design
- Minor realignment of Butlers Creek on both upstream and downstream side of Highway 401
- Works will result in minor property impacts and substantial excavation

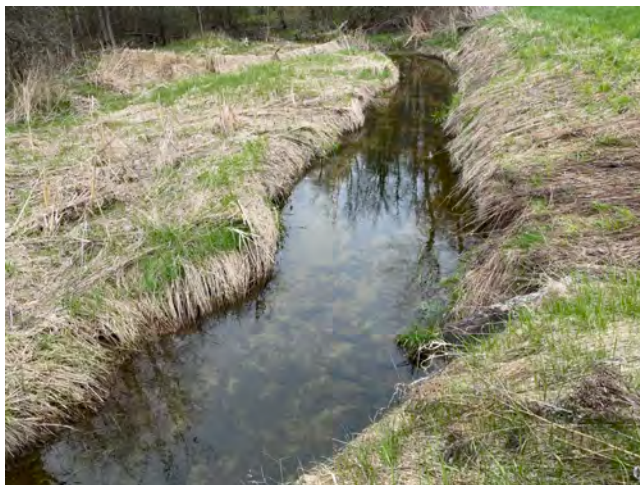
Photo 6: Site WC36; Station ET\_24+364 (Elizabethtown) - Butler's Creek; Highway 401 Westbound, facing north (upstream)

- Butlers Creek (Site 16X-0238/C0), specifically on the Highway 401 Westbound side, would benefit from enhancements to the riparian zone, such as planting shrub vegetation, in order to increase shading.
- The Unnamed Tributary to St. Lawrence River (AG\_10+050 / C5) features a large beaver dam at the Highway 401 Eastbound ROW edge that has caused the impoundment of water on both sides of Highway 401. The Tributary would benefit from having this removed, allowing for better fish passage and less potential for erosion should the beaver dam fail.
  - This feature is located outside of the Project Limits but present within the Study Area.

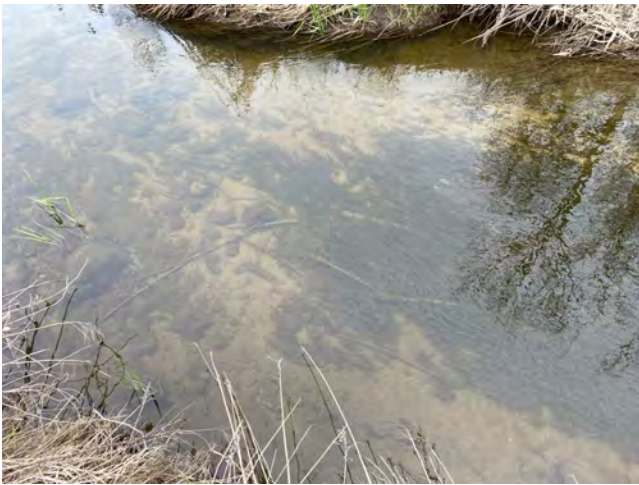
Photo 7: Site WC36; Station ET\_24+364 ( Elizabethtown ) - Butler's Creek; Highway 401 Westbound, substrate

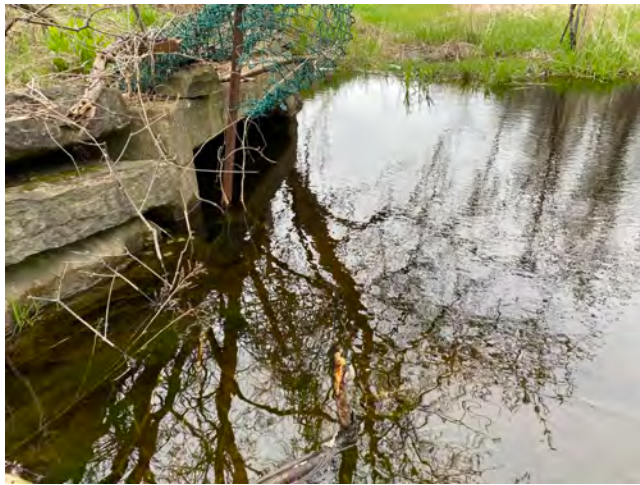
Photo 8: Site WC37; Station AG\_10+050 ( Augusta ) - Unnamed Tributary to St. Lawrence; Highway 401 Eastbound, culvert outlet facing northeast

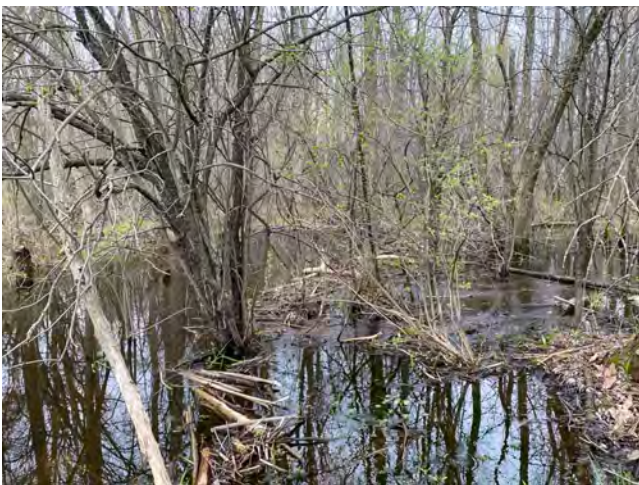
outside of the project limits, a large beaver dam was identified at the Highway 401 Eastbound ROW edge that has caused impoundment of water on both sides of the Highway. If during detail design it is identified that the beaver dam is impacting the project works, this BMP should be considered.

Photo 9: Site WC37; Station AG\_10+050 ( Augusta ) - Unnamed Tributary to St. Lawrence; Highway 401 Eastbound, facing beaver dam to southeast

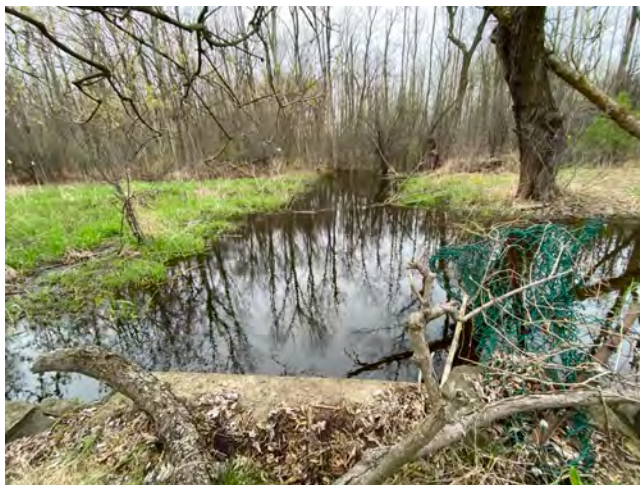
Photo 10: Site WC37; Station AG\_10+050 ( Augusta ) - Unnamed Tributary to St. Lawrence; Highway 401 Eastbound, facing southeast (downstream)

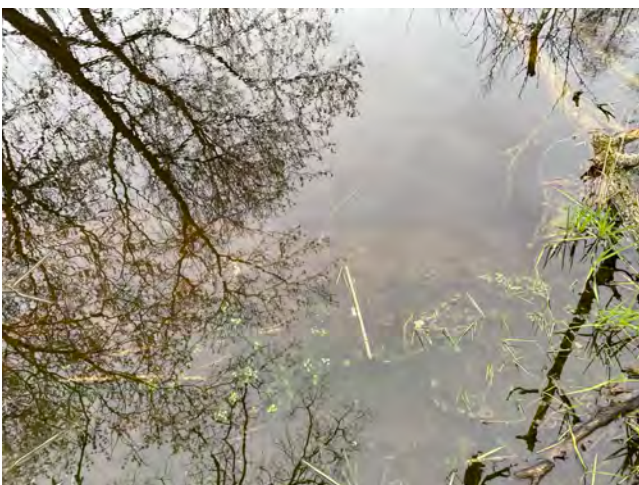
Photo 11: Site WC37; Station AG\_10+050 ( Augusta ) - Unnamed Tributary to St. Lawrence; Highway 401 Eastbound, watercress and substrate

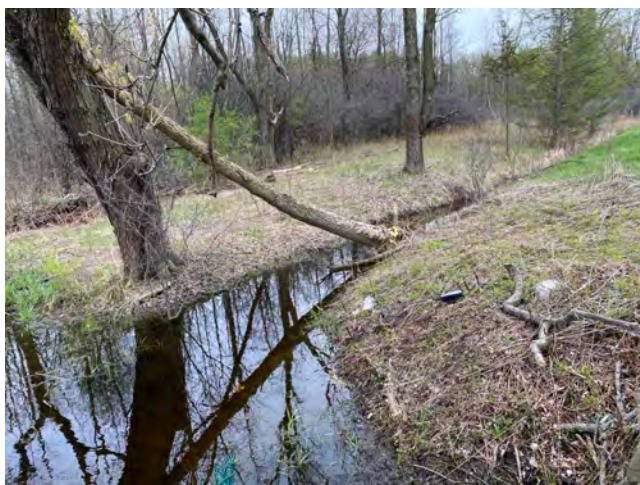
Photo 12: Site WC37; Station AG\_10+050 ( Augusta ) - Unnamed Tributary to St. Lawrence; Highway 401 Eastbound, facing southwest towards drainage ditch

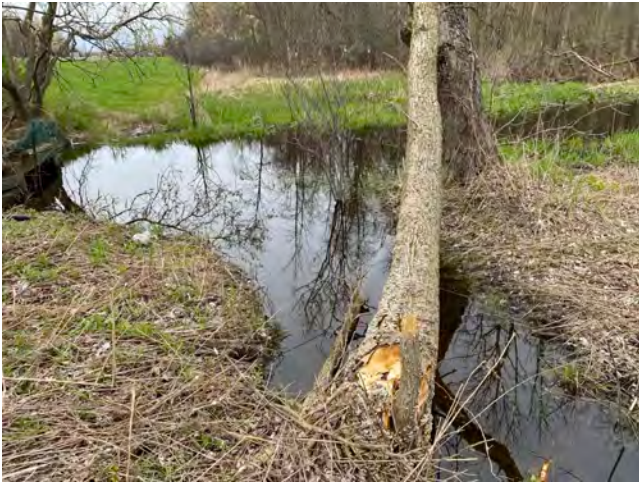
Photo 13: Site WC37; Station AG\_10+050 (Augusta) - Unnamed Tributary to St. Lawrence; Highway 401 Eastbound, confluence with drainage ditch facing northeast (downstream)

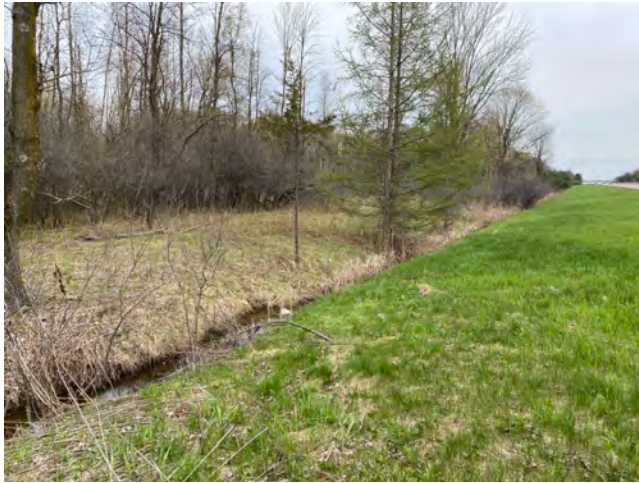
Photo 14: Site WC37; Station AG\_10+050 (Augusta) - Unnamed Tributary to St. Lawrence; Highway 401 Eastbound, drainage ditch to southwest, facing southwest (upstream)

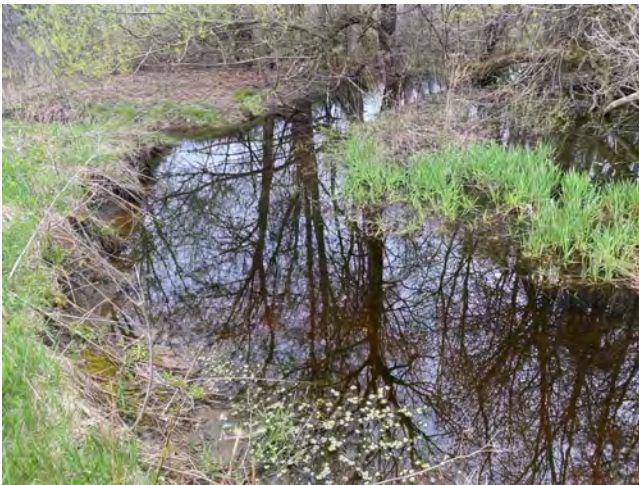
Photo 15: Site WC37; Station AG\_10+050 (Augusta) - Unnamed Tributary to St. Lawrence; Highway 401 Westbound, facing northwest (upstream)

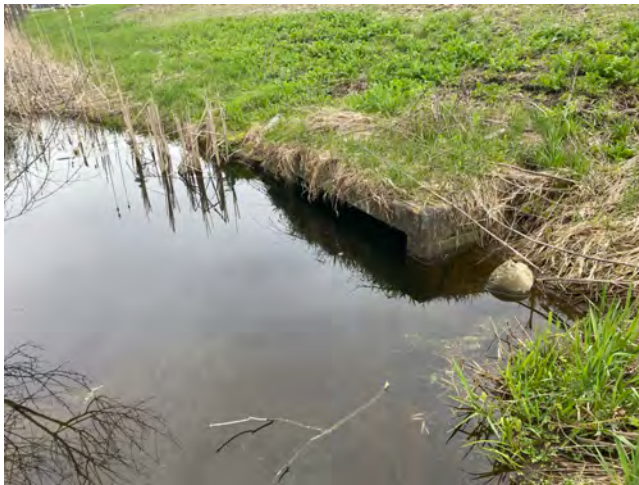
Photo 16: Site WC37; Station AG\_10+050 (Augusta) - Unnamed Tributary to St. Lawrence; Highway 401 Westbound, culvert inlet facing southeast

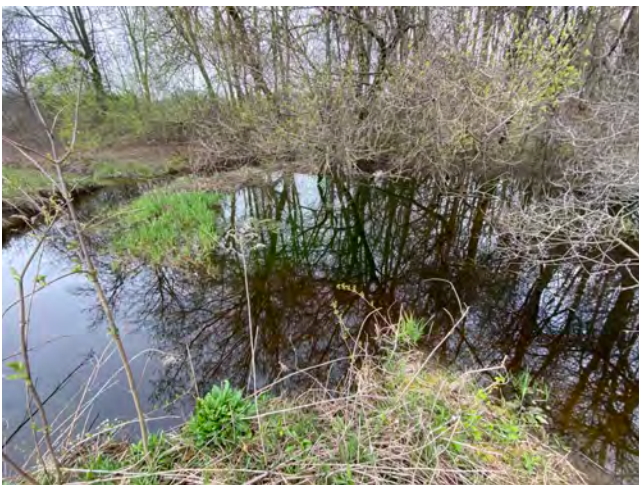
Photo 17: Site WC37; Station AG\_10+050 (Augusta) - Unnamed Tributary to St. Lawrence; Highway 401 Westbound, impounded area facing northwest

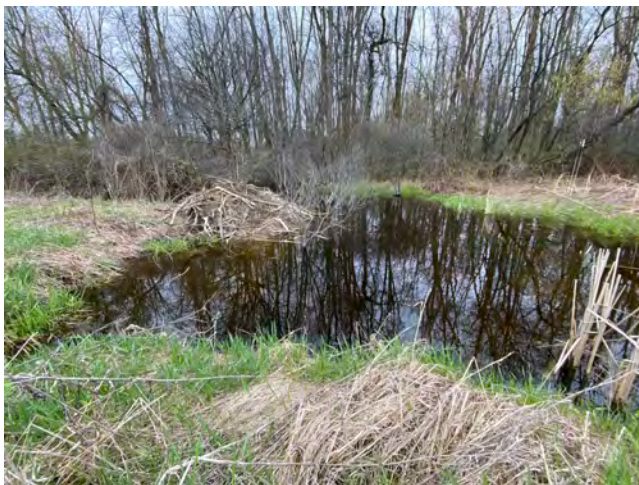
Photo 18: Site WC37; Station AG\_10+050 (Augusta) - Unnamed Tributary to St. Lawrence; Highway 401 Westbound, facing northwest (downstream)

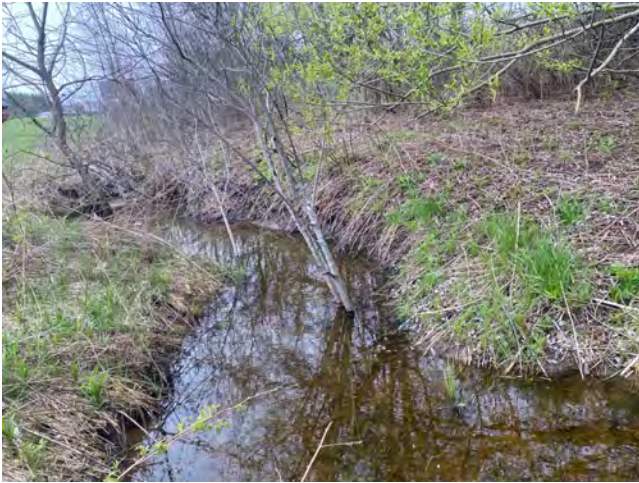
Photo 19: Site WC37; Station AG\_10+050 (Augusta) - Unnamed Tributary to St. Lawrence; Highway 401 Westbound, drainage ditch to southwest, facing southwest (upstream)

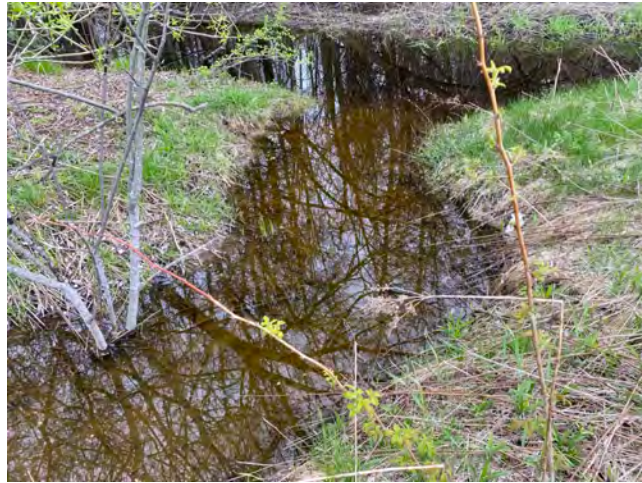
Photo 20: Site WC37; Station AG\_10+050 (Augusta) - Unnamed Tributary to St. Lawrence; Highway 401 Westbound, confluence with drainage ditch facing northeast (downstream)
